APPLICATION NOTE

Nanoprobng SEM Solution for In Situ Semiconductor Failure Analysis

Failure analysis measurements for automotive industry are conducted to identify and localize fabrication defects in transistors and integrated circuits interconnections. Resistivity measurements, transistor characterization, EBIC and EBAC are here performed with Imina Technologies nanoprobng platform and successfully used to achieve this goal.

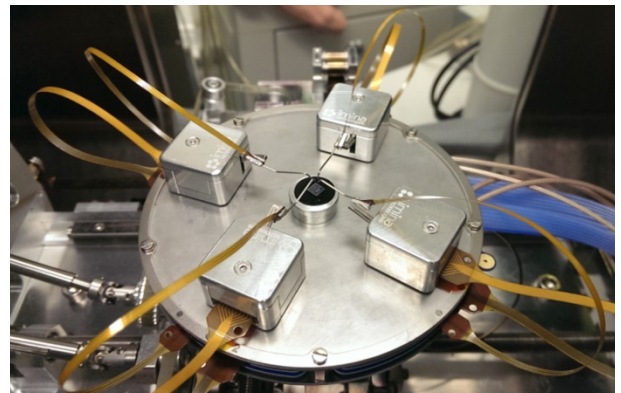
Figure 1: Four miBot™ nanomanipulators placed around the device under test on a Nanoprobng SEM Platform. The platform is mounted on the SEM sample stage.

The measurements presented hereafter were performed with the Imina Technologies Nanoprobng SEM solution loaded with four miBots and the device under test [Figure 1].

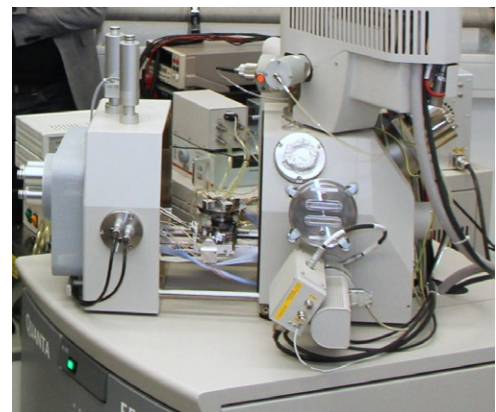
Figure 2: Photograph of the FEI Quanta 650 ESEM that was used for the experiments.

The platform was installed in a FEI Quanta 650 ESEM [Figure 2]. Electrical measurements were performed with a Keithley 4200-SCS semiconductor parametric analyzer. EBIC and EBAC analyses were made with a DISS 5 (Point Electronic GmbH).

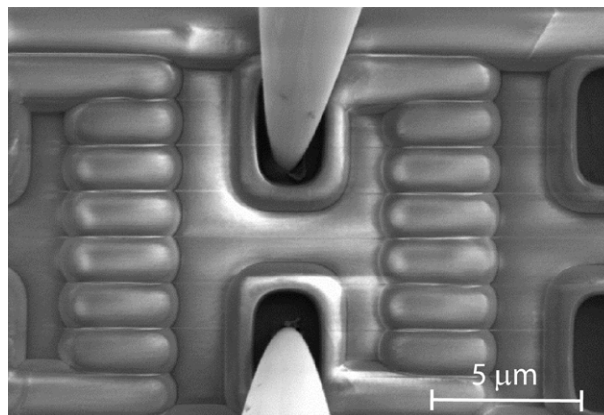
Figure 3: Probing at exposed alumina parts to investigate low ohmic VIA chains.

Low resistivity measurements have been realized on a faulty VIA chains process monitoring structure [Figure 3]. The probing has been carried out at exposed alumina parts. Results are presented in Figure 4. The resistivity of the failing VIA chain shows a value of 225 Ω and is 40% higher than the reference value of 160 Ω . A FIB cross section revealed a misalignment between a metal line and the relative interconnection, resulting in a reduced contact surface.

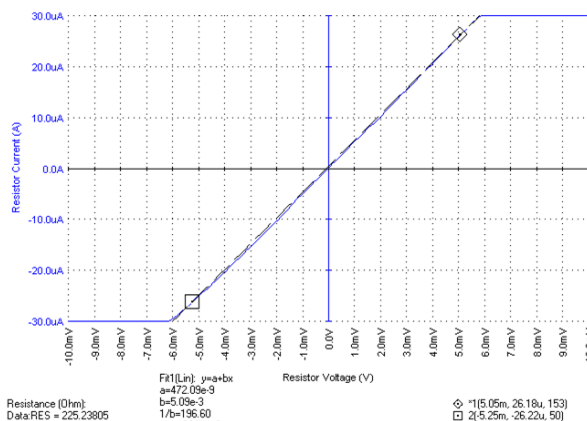
Figure 4: Resistivity measurement of VIA chains.

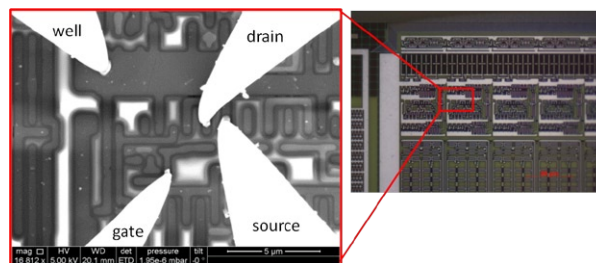
Figure 5: Electrical probing of a single PMOS transistor.

In this example, PMOS transistor characteristics were measured with the nanoprobng method. First metallization levels were removed by chemical-mechanical polishing in order to isolate a single transistor and to have access to alumina metal lines. Then, four tungsten needles were put in contact with the source, drain, gate and well nodes of the transistor [Figure 5]. A Keithley 4200 SCS semiconductor characterization system was used to generate I/V curves of source and drain for several gate potentials [Figure 6].

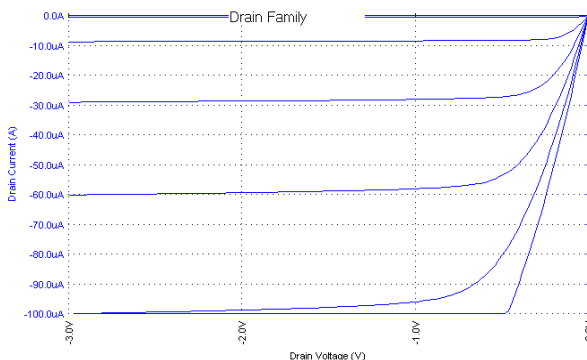
Figure 6: Transistor characteristics: I/V curves function of different gate voltage potentials.

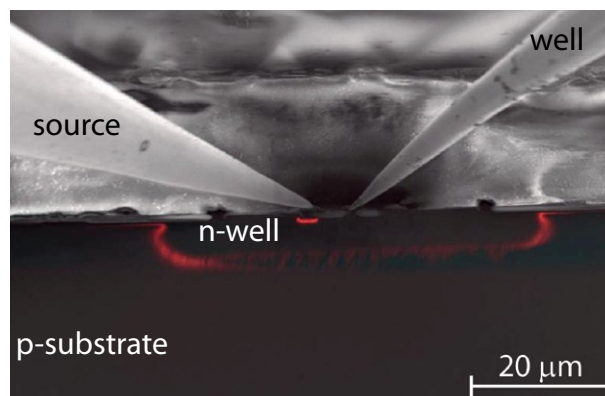
Figure 7: Large EBIC imaging of a double PMOS transistor cross section. The two probes are connecting respectively the right transistor source and the well. The red color represents the intensity of the EBIC induced current generated along the p-n junction depletion regions.

Probe needles are placed in contact with the transistor source and well which are separated by a p-n junction. The electron beam generated current is mapped by the EBIC scanning system and overlaid to the microscope secondary electron image. The electron beam is incident on the PMOS transistor cross section with an acceleration voltage of 2 keV [Figure 7]. The cross section analysis allows a reduced electron accelerating voltage and therefore a very high resolution due to a small interaction volume.

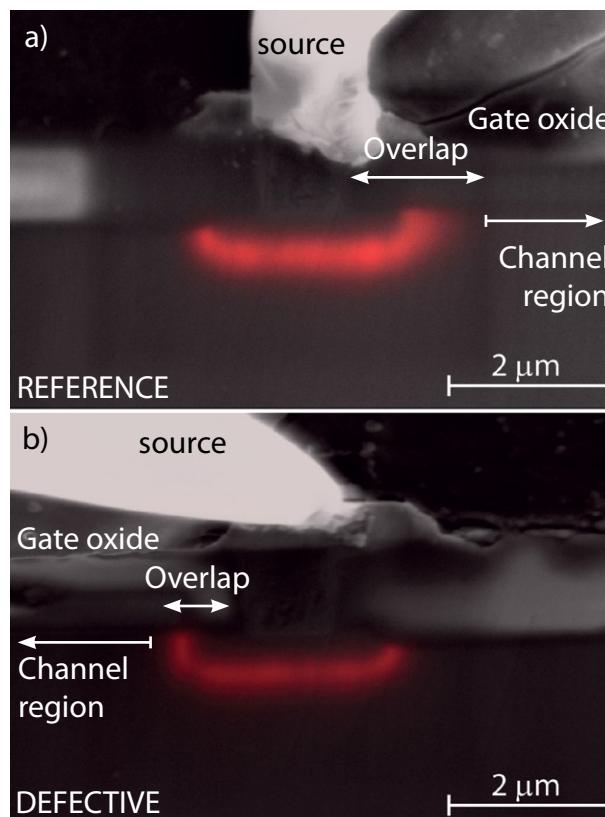
Figure 8: a) EBIC scan of the reference transistor source. The depletion region is extended along the channel region. b) EBIC scan of the defective transistor source. The depletion region is not enough extended along the channel region. This leads to a longer conductive channel and therefore to a higher transistor resistance.

The source depletion regions of the reference transistor and of the defective transistor are compared [Figure 8]. Investigators have seen that the defective transistor has a small overlap with the gate oxide structure in comparison to the reference transistor. This anomaly leads to a longer channel region of the defective transistor which causes the drain current reduction. The fabrication defect is therefore indentified with the short extension of the source p-n junction below the gate oxide.

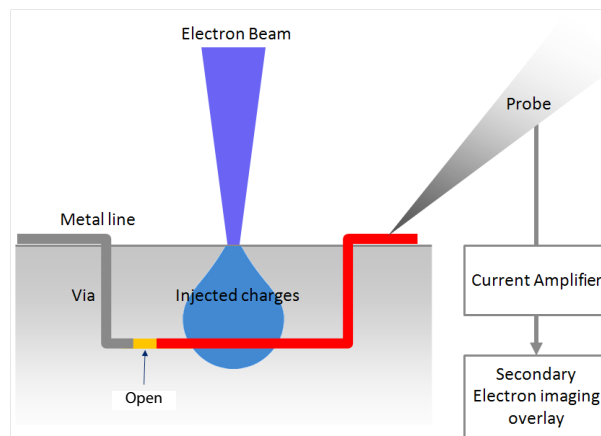
Figure 9: Schematic of the EBAC characterization principle.

The combination of resistivity measurements, presented above, and the EBAC technique provides a powerful means to characterize metal interconnects of integrated circuits. The EBAC technique is based on a similar principle as EBIC. The electron beam of the SEM scans the sample and injects charges inside a certain interaction volume. Injected charges are absorbed by metal lines under the surface. A current is then induced and measured by a probe placed at contact level on one end of the metal line of interest [Figure 9]. As for EBIC, the probed signal is overlaid on the secondary electron image. Direct comparison of this image with layout details allows the investigator to easily detect and finely localize shorts and/or opens.

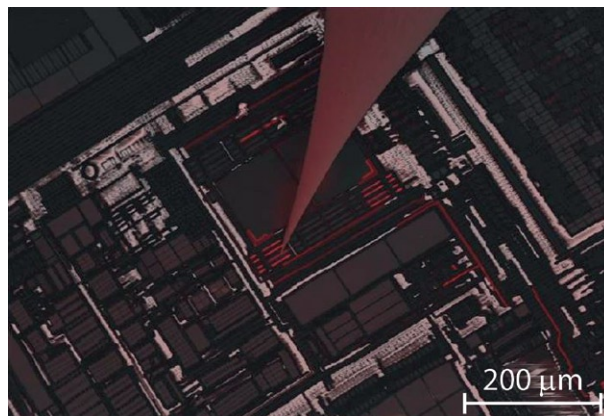
Figure 10: Backside of an integrated circuits analyzed with EBAC technique. In red, the absorbed current flowing in the metal lines linked with the probe. The electron beam accelerating voltage for EBAC measurements is 10 keV.

Here, silicon is completely removed from the backside to access small lower metal lines. One miBot™ was used to probe at contact level (tungsten plugs with diameter of

approximately 350 nm) to investigate metallization of a complete integrated circuit. The red color indicates that the metal lines are electrically connected to the manipulator probe [Figure 10].
