APPLICATION NOTE

Defect Localization at Transistor Gate using Electron Beam Induced Resistance Change (EBIRCh)

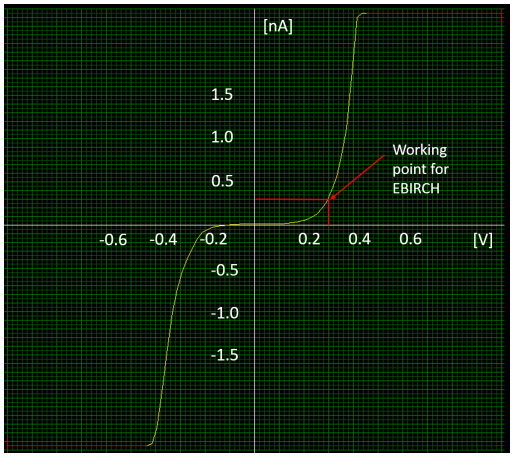
Figure 3. I/V curve recorded between gate and bulk of the defective transistor. Current has been limited to 2.5nA to avoid further damages at the gate oxide.

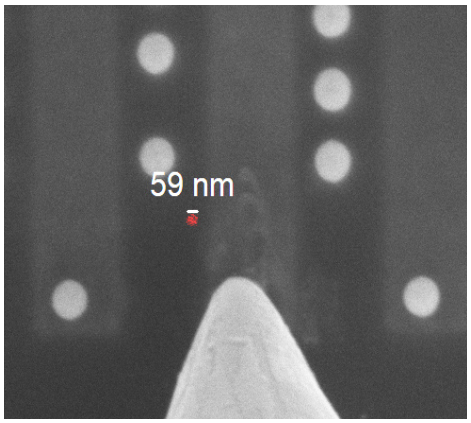
On this image, a bright red spot of 59nm can be identified. It is the location in the sample where the resistance between the two probes changes the most upon electron beam exposure. It corresponds to the location of the defect in the gate oxide, and its position is known within tens of nanometers. The high accuracy of the defect localization obtained in this case allows the failure analyst to be certain that the defect will be contained in a single TEM lamella prepared from the vicinity of the spot, avoiding the preparation and observation of several TEM lamellas not containing the defect.

Figure 5. Overlay of Secondary Electron image and EBIRCh image. A spot of 59nm is highlighting the location of the defect in the gate oxide.
